Iron-oxidising bacteria associated with springs on Pinn Meadows.

John Scrivens 17.02.2022

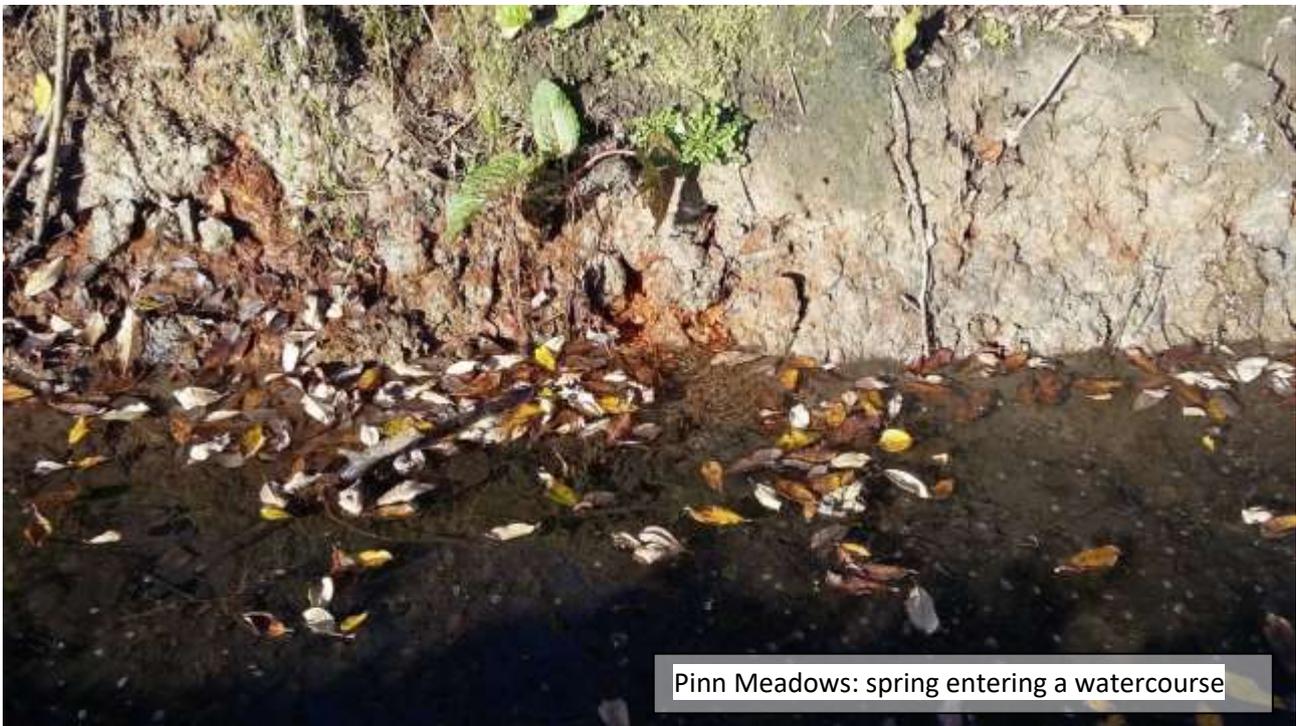
Pinn Meadows: spring entering a watercourse

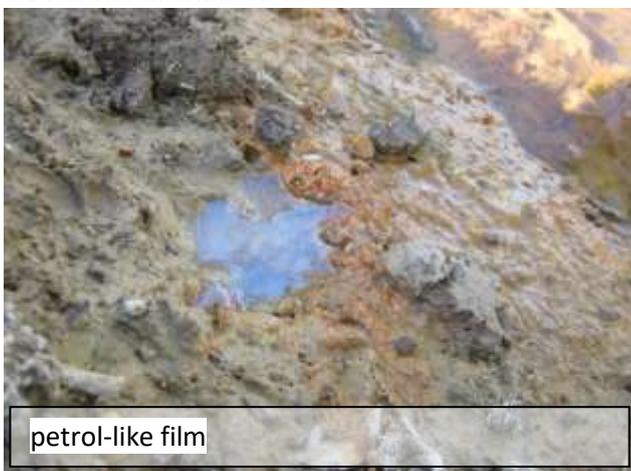
petrol-like film

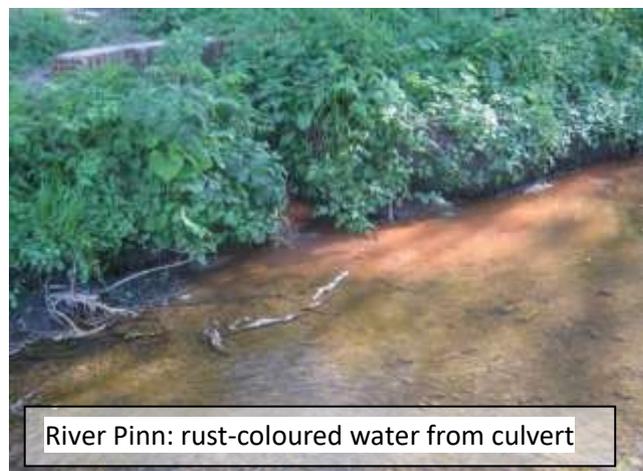
River Pinn: rust-coloured water from culvert
