# **That sinking feeling: geology, people and subsidence**

Phil Collins

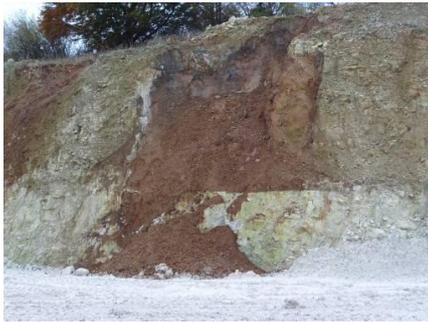
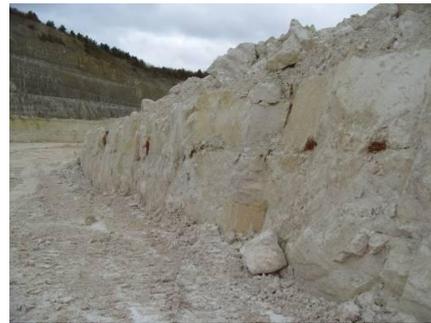
**Clay-with-Flints in solution features at surface and 50m down, Dunstable Chalk quarry**

Solution dolines were illustrated by solution pipes at Kensworth Quarry near Dunstable in Bedfordshire, where solution pipes are filled with clay-with-flints. Typically the contact between the chalk and clay-with-flints is undulating because it is a solution contact. At the same quarry, clay-with-flints can be seen in a solution feature 50m below the surface. Although many such features are infilled, they are often completely open and the use of borehole cameras has shown voids several cm high.

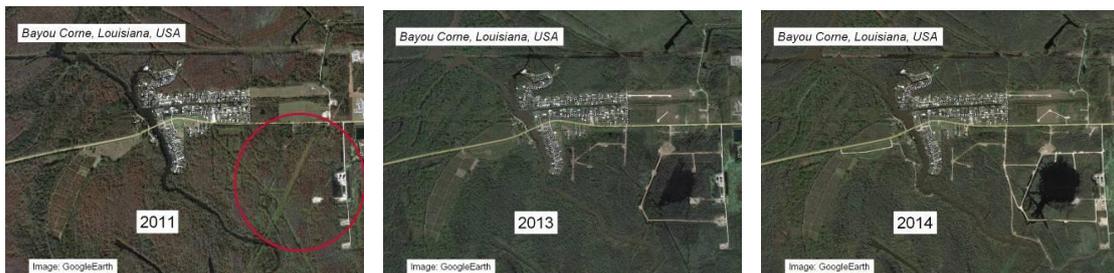
**Development of subsidence above brine extraction, Bayou Corne, Louisiana**

At Bayou Corne, Louisiana, Texas Brine Inc began pumping brine from a salt deposit in 2011. This resulted in subsidence and the appearance of a small lake on the surface within 2 years, which was even bigger in 2014. The salt domes being exploited are linked to hydrocarbons so oil and gas come up from a depth of 4,000ft into the lake. The brine well was on the edge of the salt dome and following salt solution, the wall rock collapsed in, leading fairly rapidly to ground subsidence.
