Geology of the HS2 route through the Chilterns and the Colne Valley

Clive Edmonds

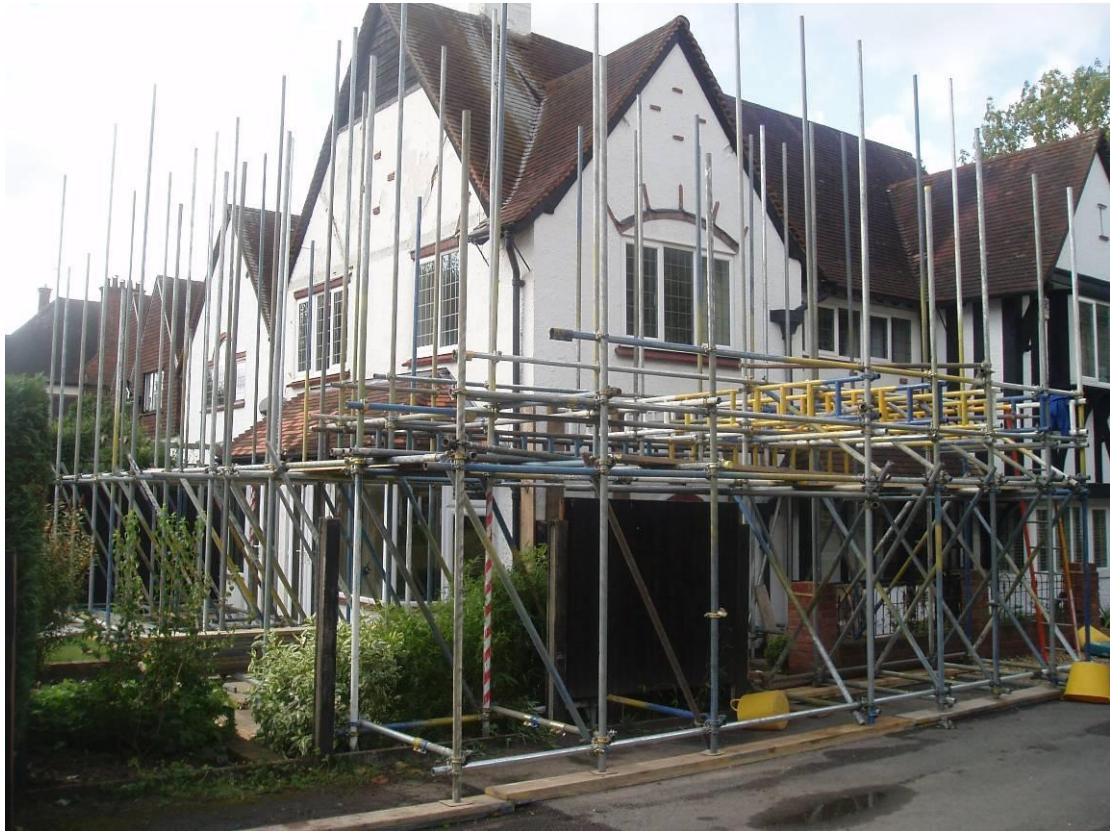
A – The Greenway, Chalfont St Peter had a subsidence problem due to a deep clay plug beneath the property within a solution feature that extended to more than 50m depth. The geology is Beaconsfield Gravel over Chalk.

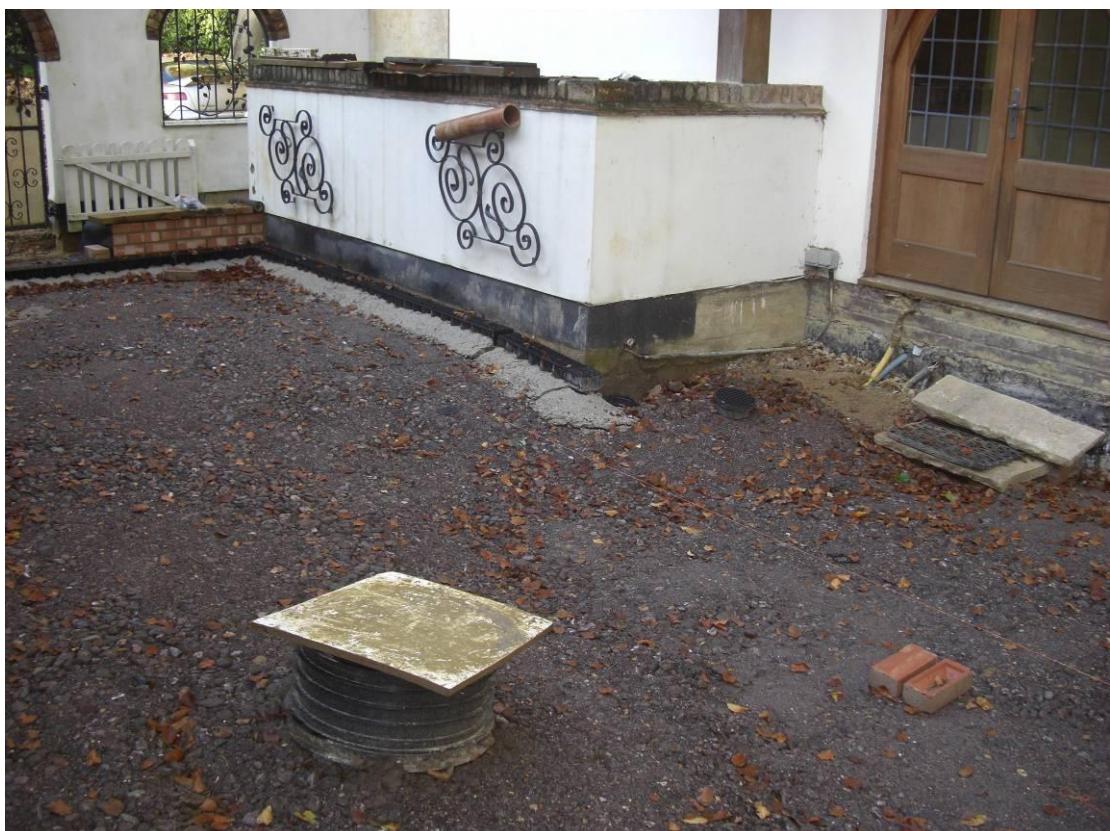
B – Welders Lane, Chalfont St Peter had a 30-40m deep solution feature and subsidence was caused by a change in the drainage.

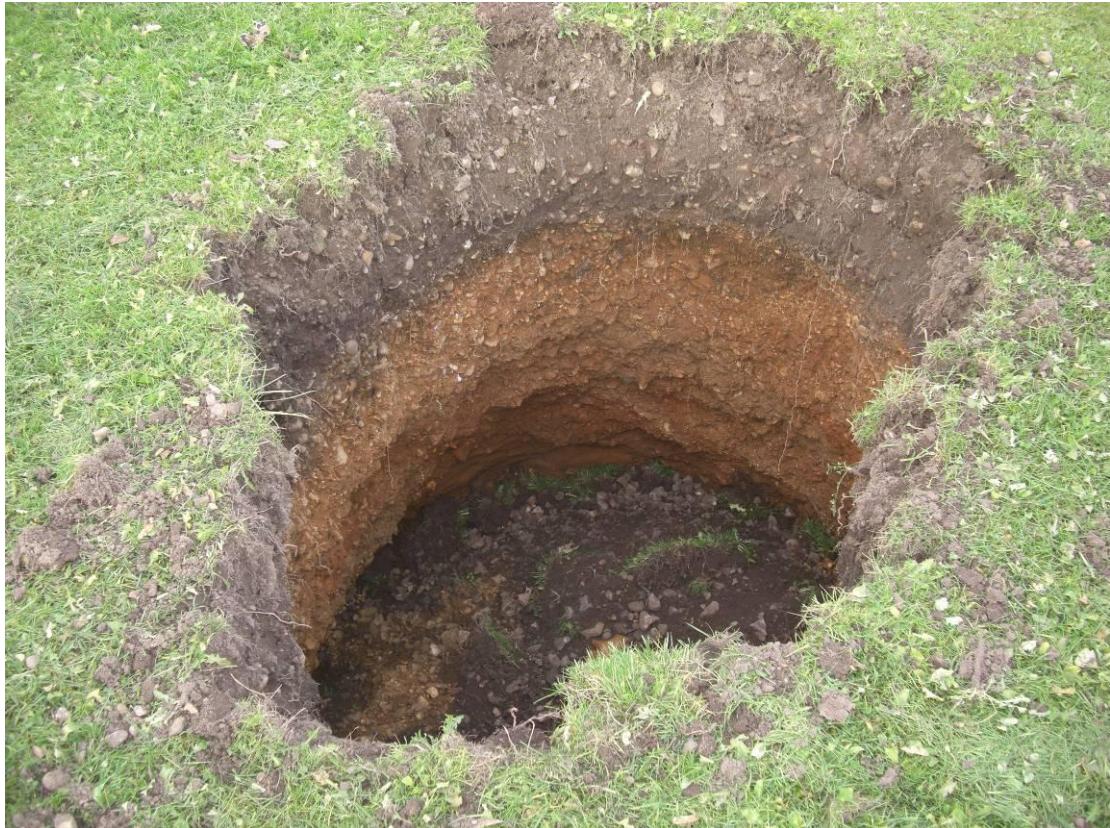
C – Wooburn Green Lane, Beaconsfield had a 3m diameter, 2m deep hole develop in a sports field.
